Re: RH energytrans, LLC  
Docket No. CP18-06-000 Bi-Weekly Status Report No. 38

Picture Log to Bi-Weekly Report

Bi-Weekly Report Number. 38

Date Range: 05/14/2020 to 05/27/2020

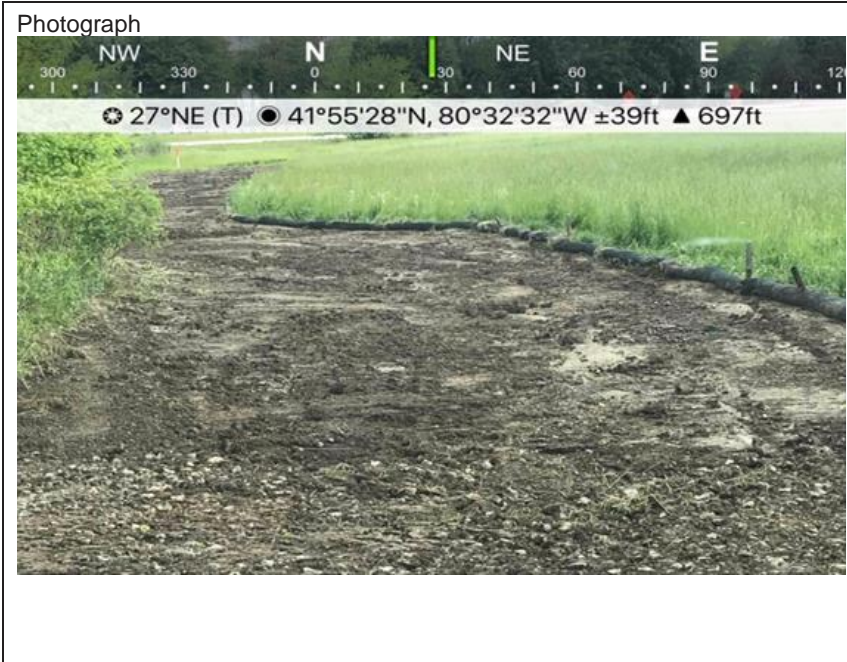
<p>Aspect: Northeast</p> <p>Photo Number: 3</p> <p>Mile Post: 49.4</p> <p>Description:          TAR-8. Restoration recently completed in this area. TAR-8 was located in agricultural field. Area seeded not mulched per landowner requirement. Area is stable. E&amp;S controls in place functioning properly.</p>
<p>Photograph</p>

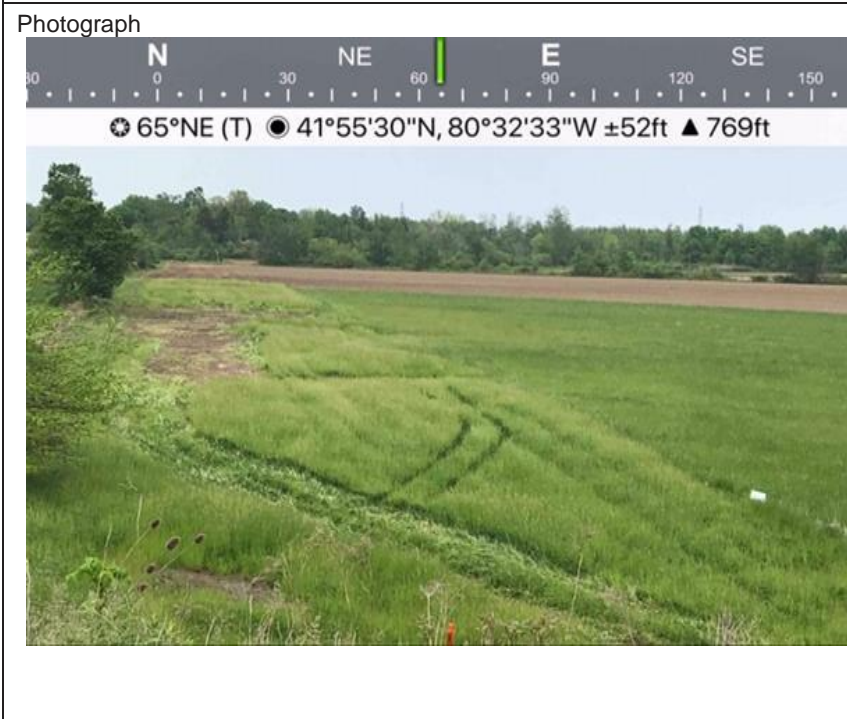
<p>Aspect: East</p> <p>Photo Number: 4</p> <p>Mile Post: 49.3</p> <p>Description:          From Middle Road. Restoration had been completed in this area. Some low spots have been re-graded and re-seeded. E&amp;S controls in place and functioning properly.</p>
